# **NATIONAL TRANSPORTATION SAFETY BOARD**

## **REAR SPAR DAMAGE MARKERMEER, NETHERLANDS AND ANTELOPE ISLAND, UT 14 PHOTOGRAPHS PART 1**

Aircraft: Czech Aircraft Works Zodiac 601XL

Aircraft: Experimental Zodiac 601XL

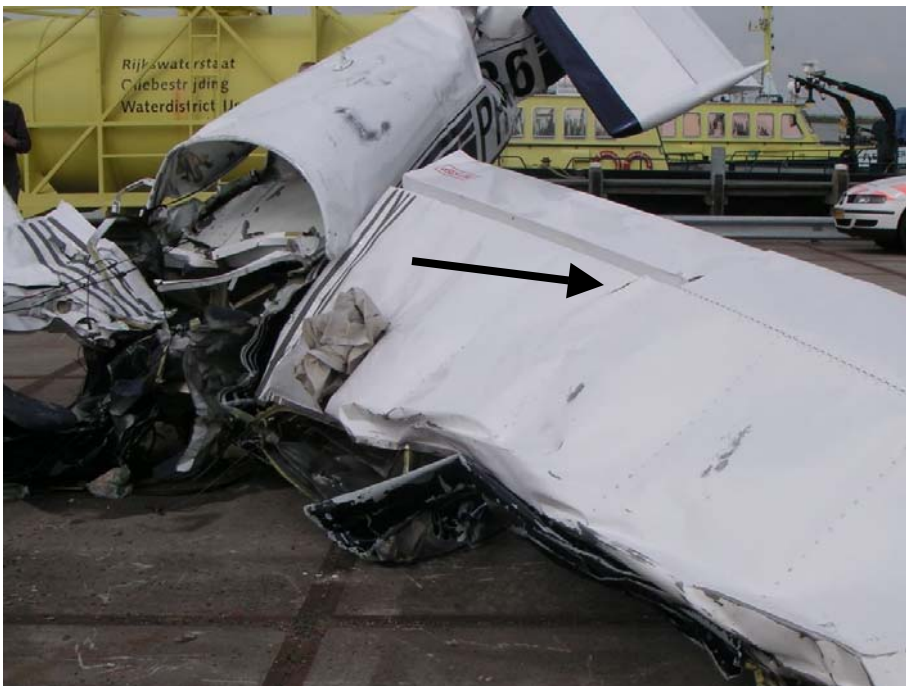
Left wing, upper buckle

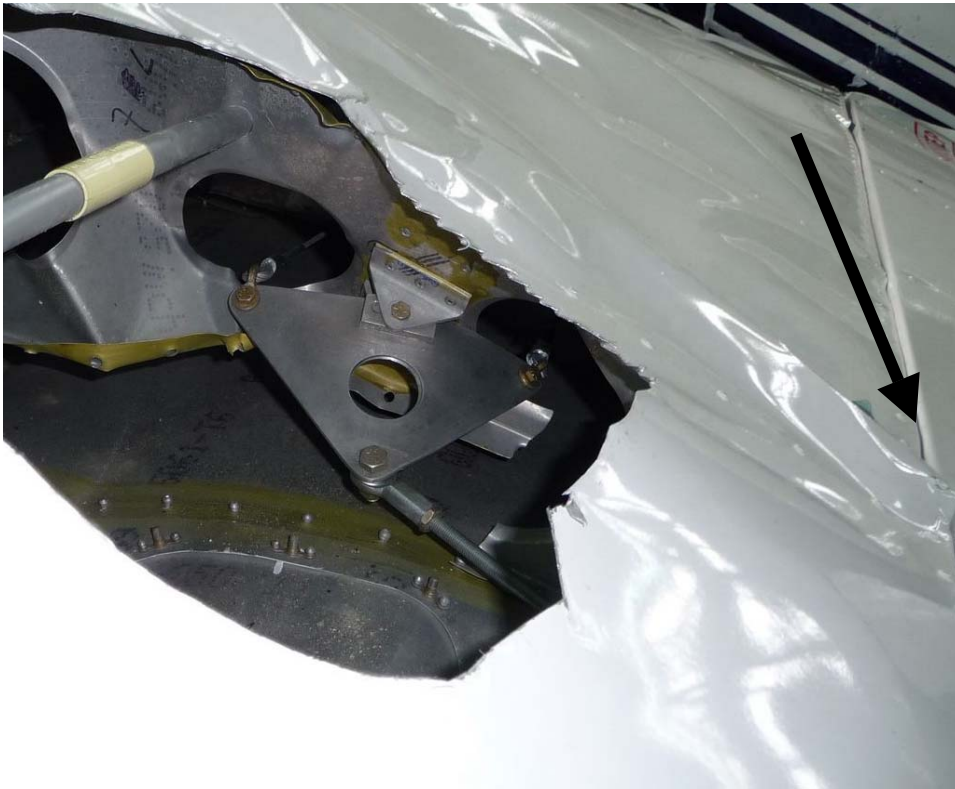
Left wing, upper buckle

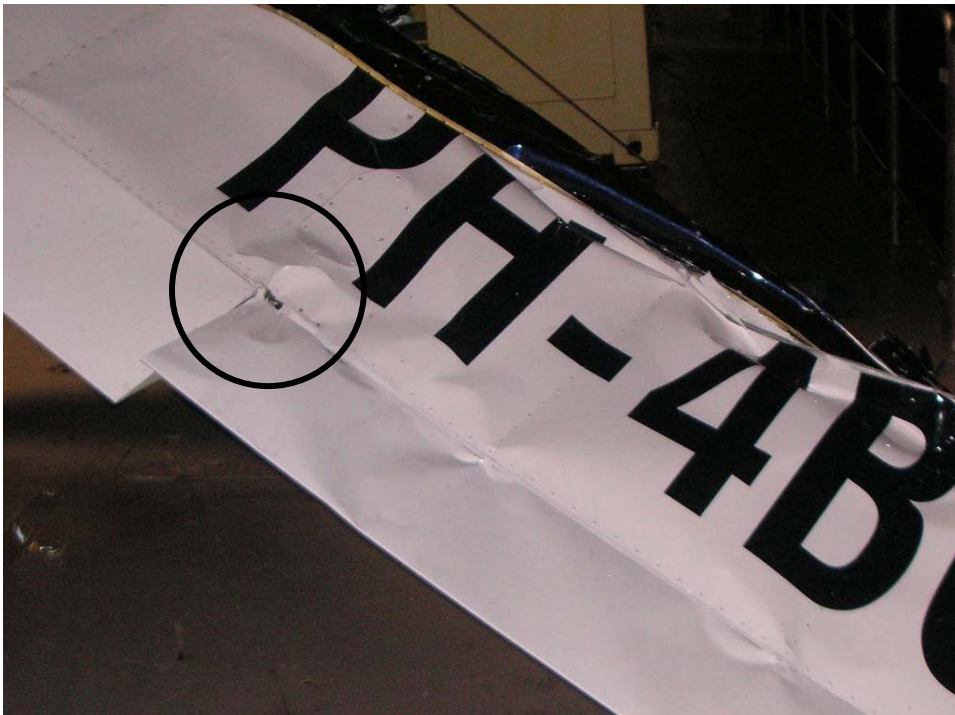
Left wing, lower buckle

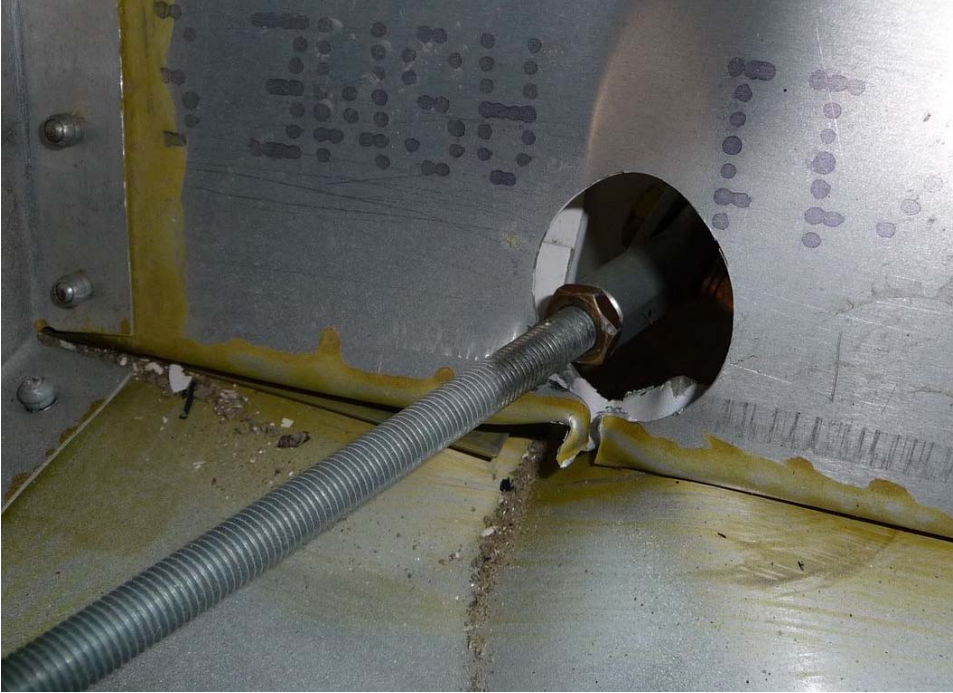
Left wing, lower buckle

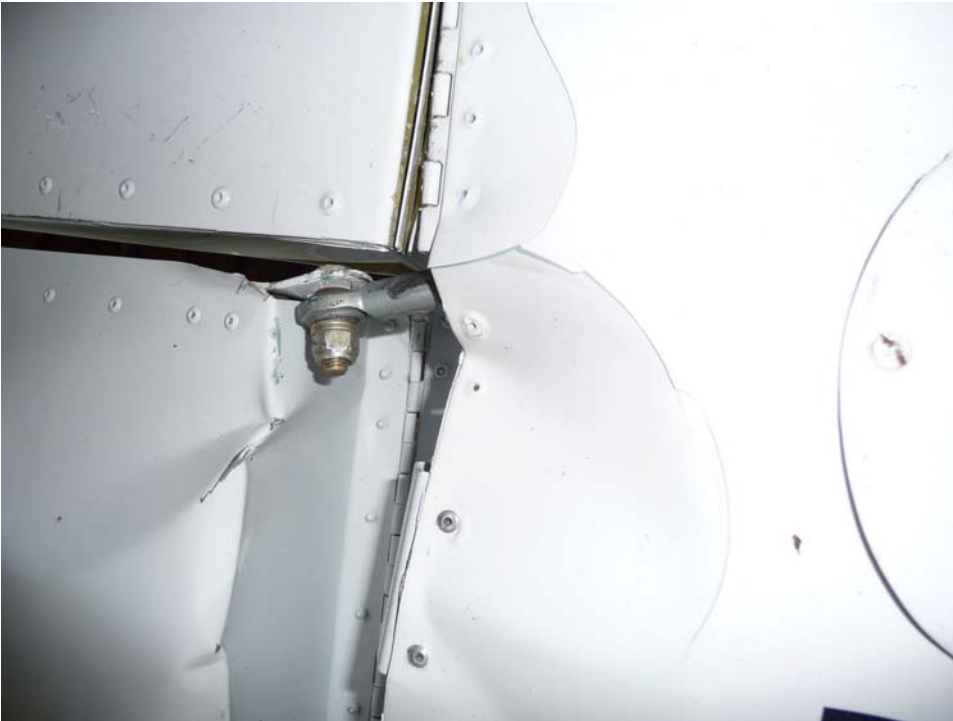
Left wing, lower buckle

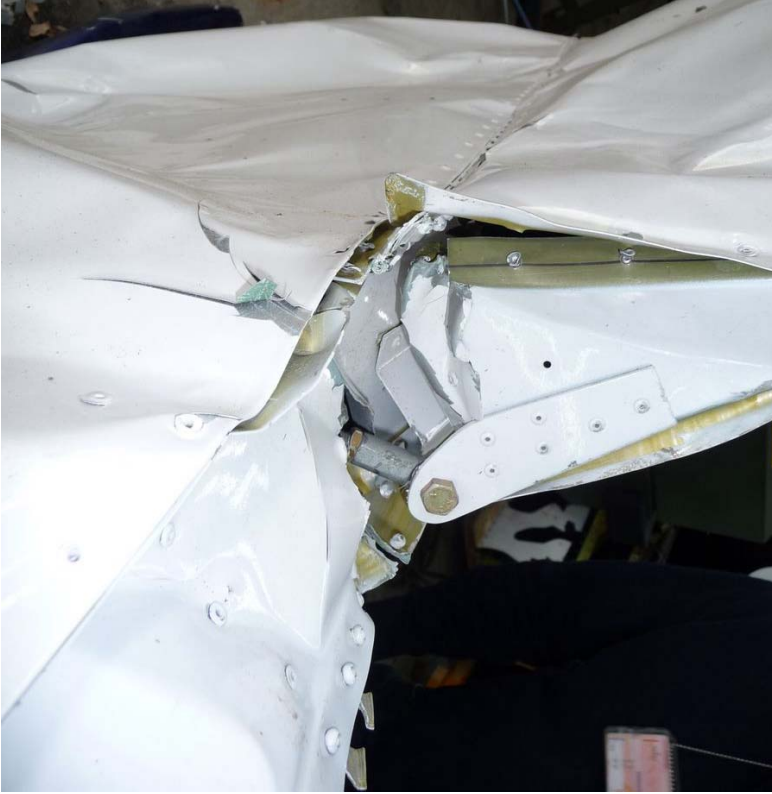
Right wing, upper buckle

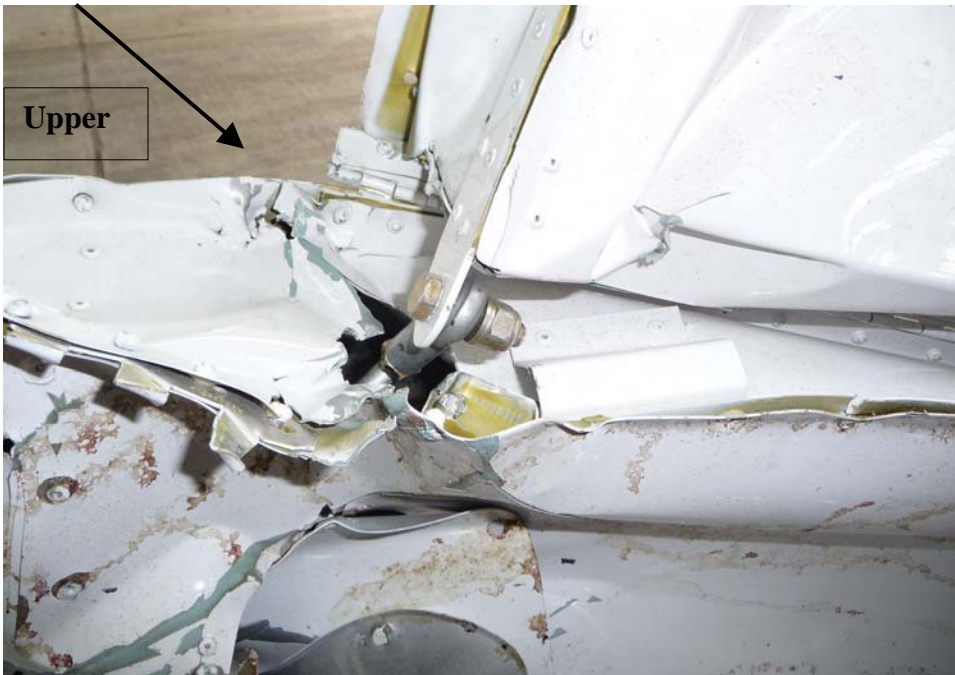
Right wing, upper and lower buckles

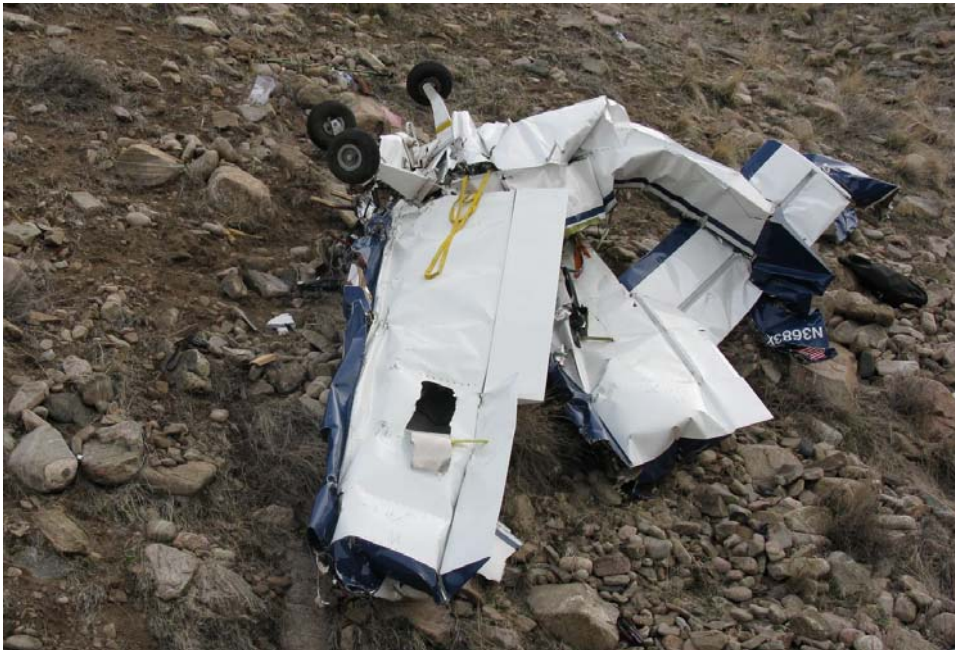
Right wing, lower surface

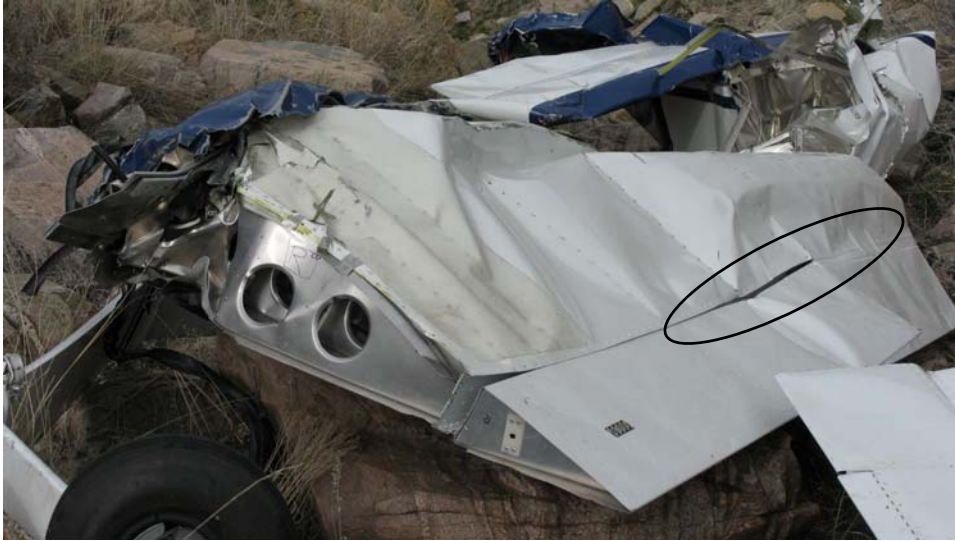
Right wing, lower buckles

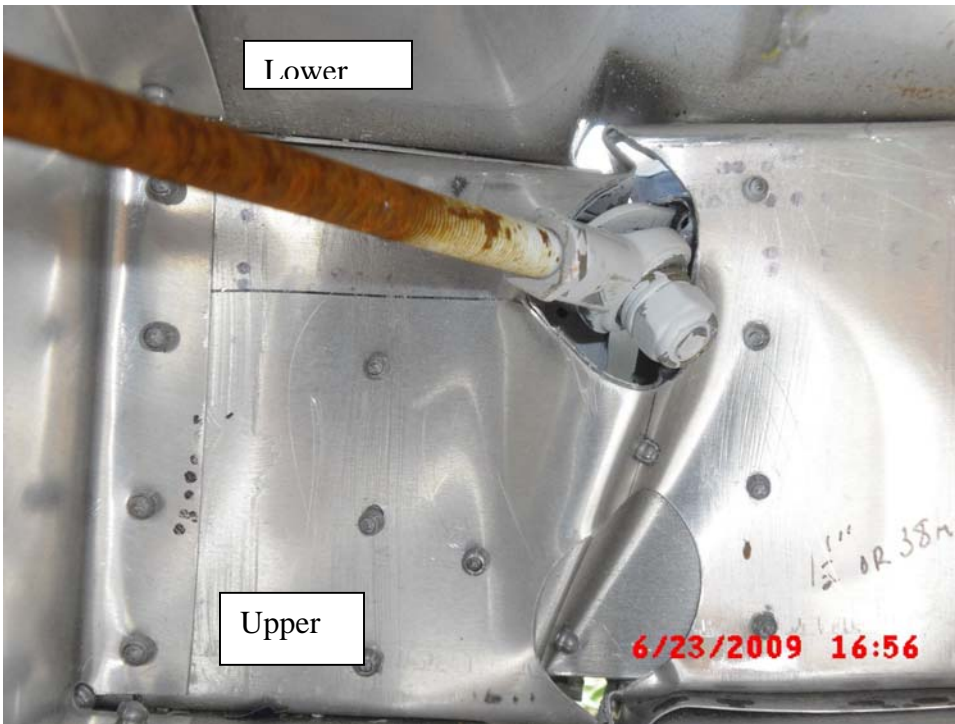
Right wing, upper and lower buckles

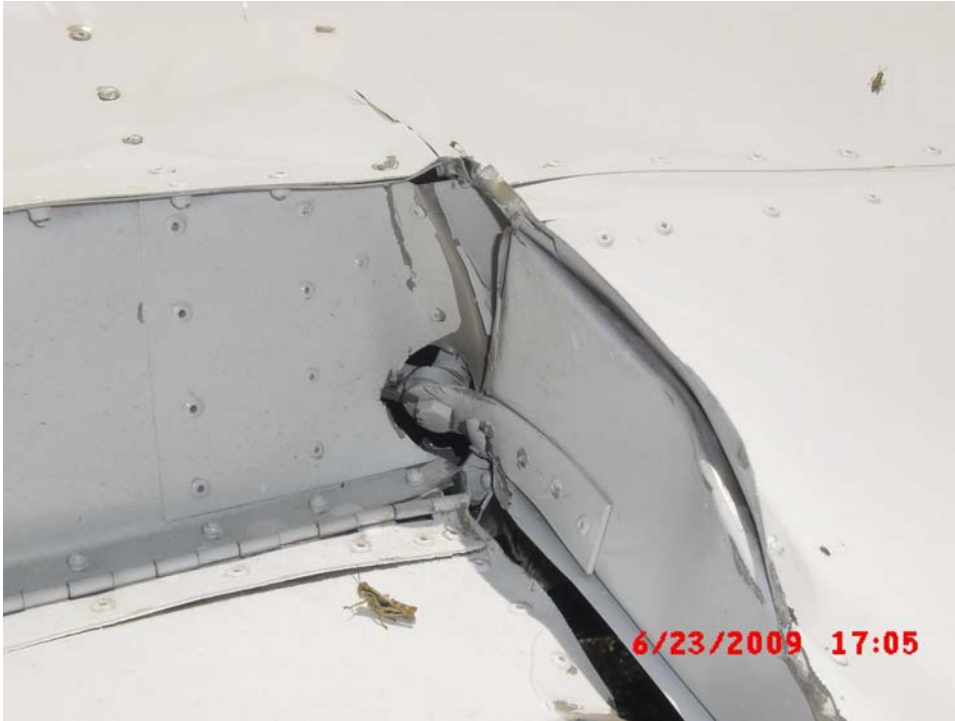
Right wing, upper and lower buckles

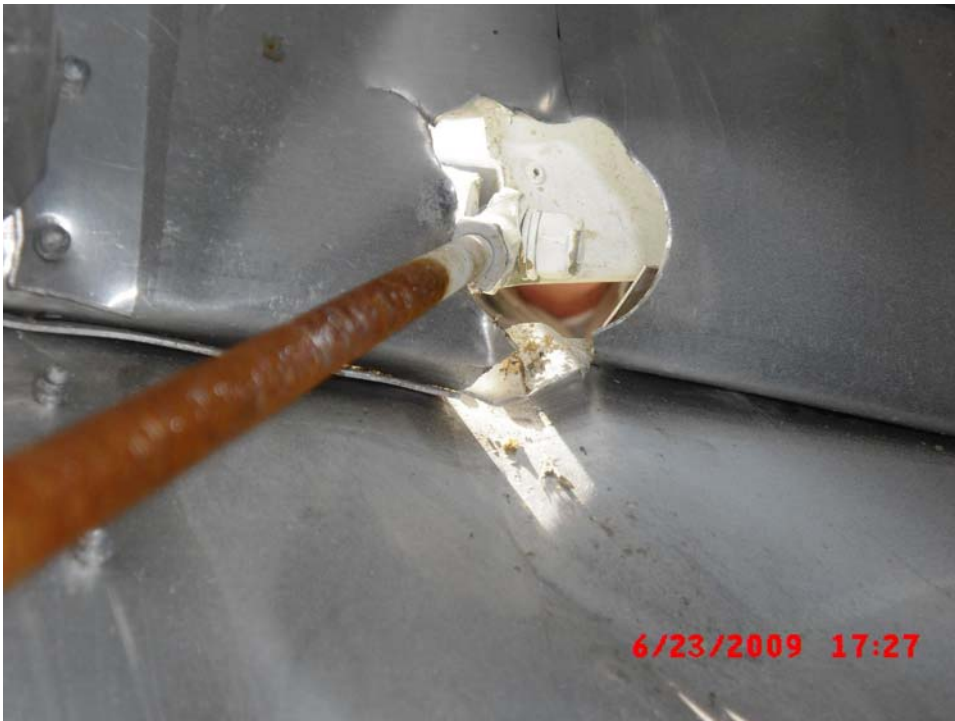
Left wing, lower buckle

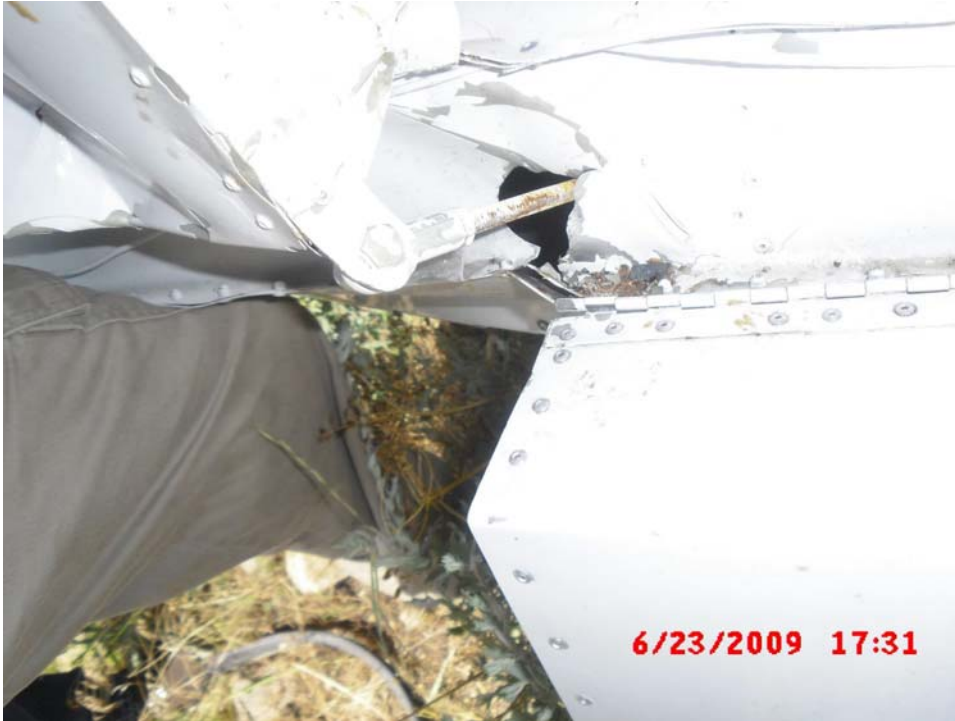
Left wing, lower buckle
