NATIONAL TRANSPORTATION SAFETY BOARD

REAR SPAR DAMAGE POLK CITY, FL AND OAKDALE, CA 8 PHOTOGRAPHS PART 2

Aircraft: Czech Aircraft Works Zodiac 601XL

REAR SPAR DAMAGE OF SIX ZODIAC AIRPLANES (PART 2, POLK CITY, FL AND OAKDALE, CA)

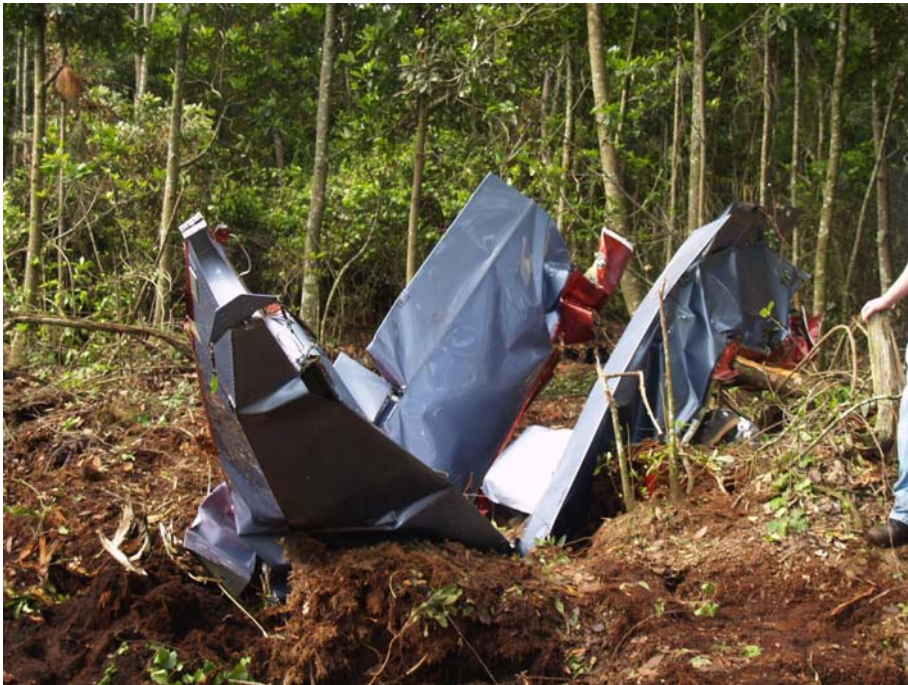
The Polk City accident: the left wing wrapped around the fuselage, the right wing was relatively straight.

Left wing wrapped around fuselage

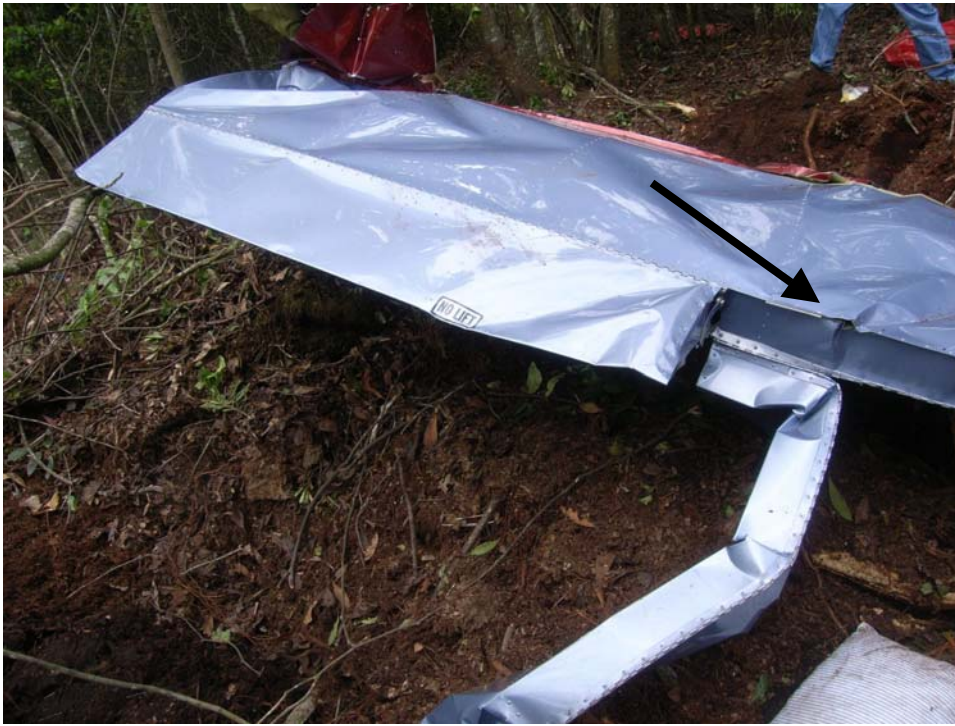
Left wing, upper buckle

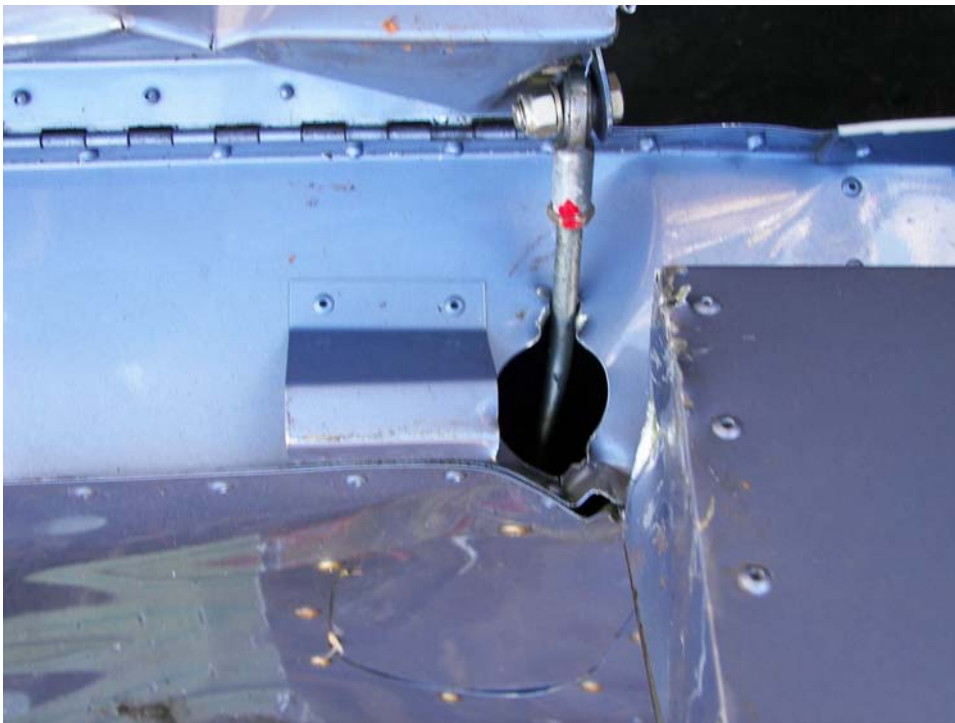
Left wing, lower buckle

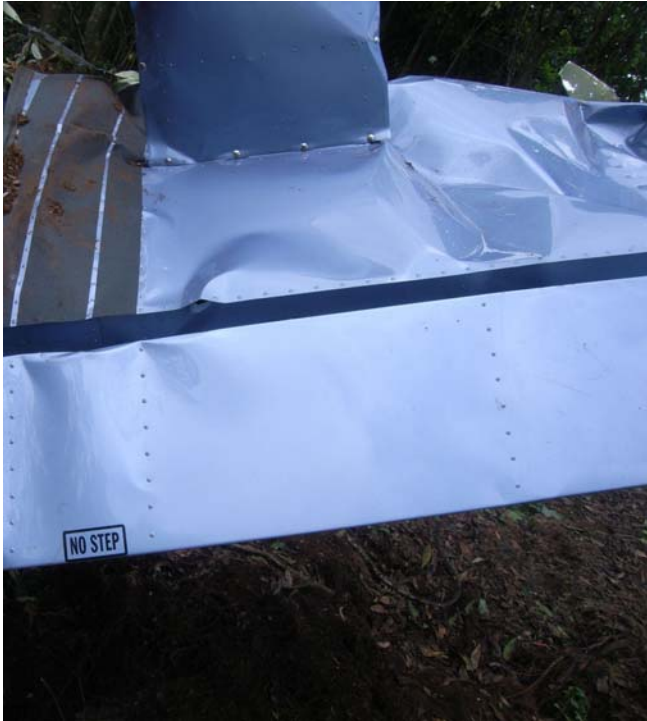
Right wing, upper buckle

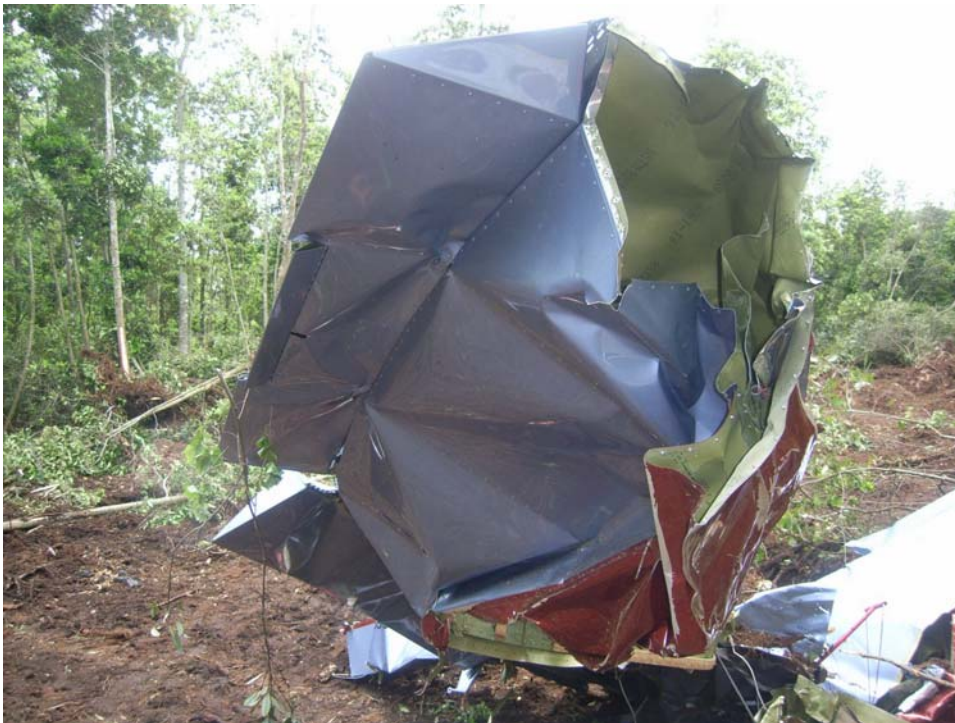
Right wing, lower surface, no apparent buckle at inboard end of aileron, other buckle may be due to leading edge impact.

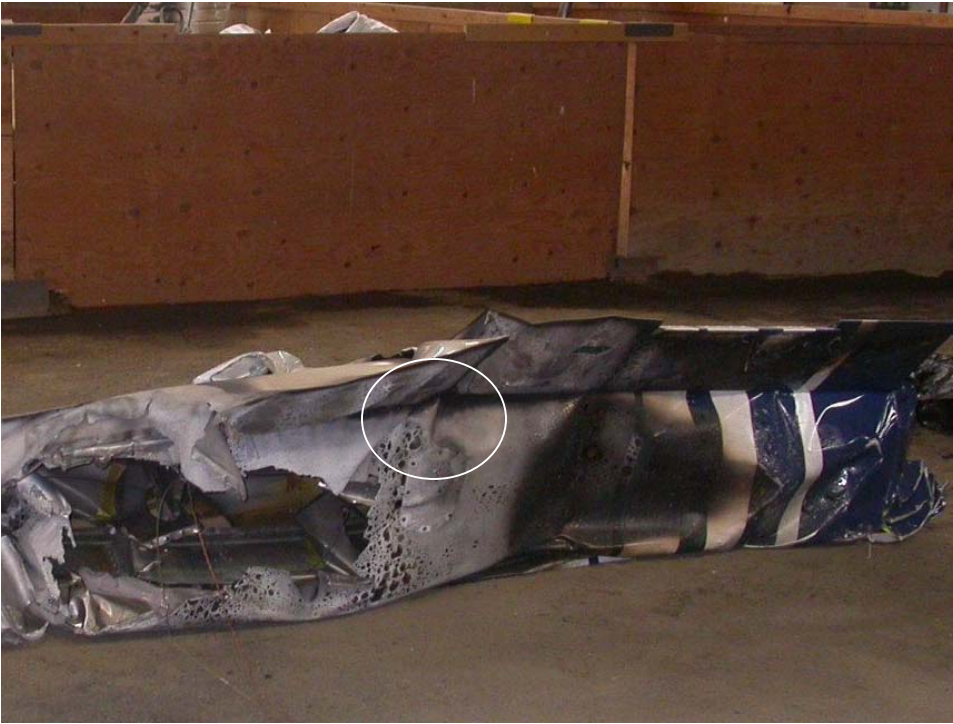
The Oakdale, CA accident: both wings broke in down bending.

Right wing, lower surface

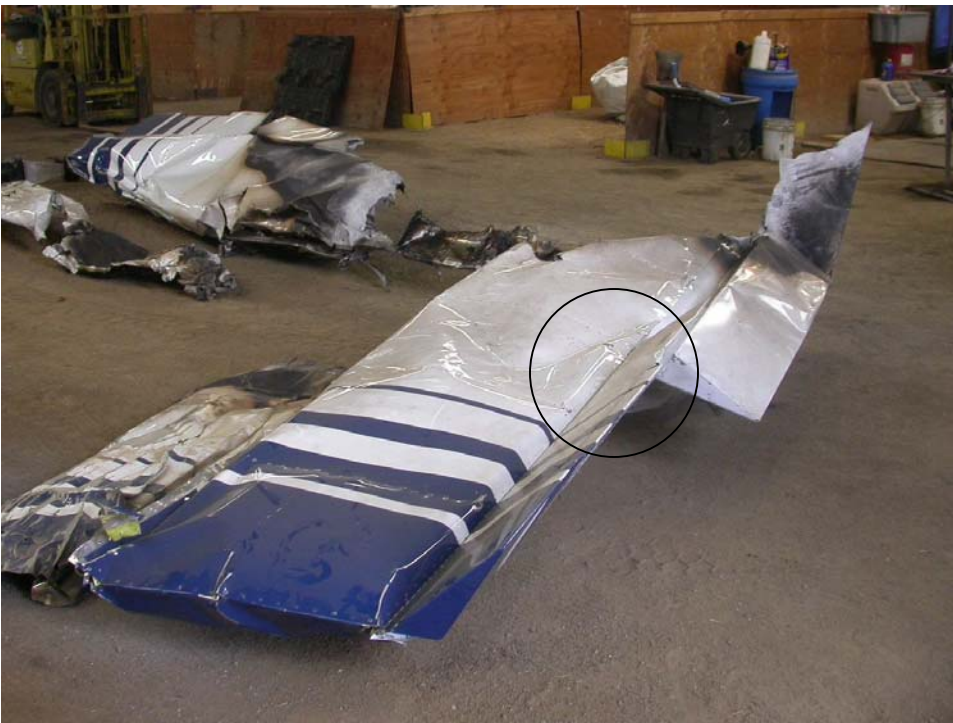
Left wing, upper buckle

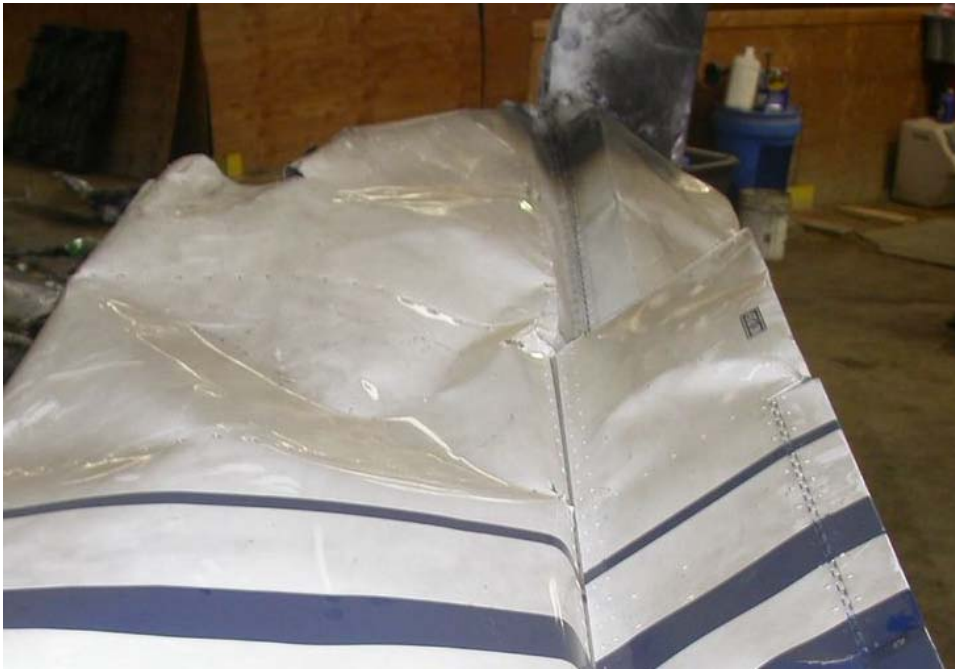
Left wing, upper buckle
