NATIONAL TRANSPORTATION SAFETY BOARD

REAR SPAR DAMAGE SPAIN AND YUBA CITY, CA 8 PHOTOGRAPHS PART 3

REAR SPAR DAMAGE OF SIX ZODIAC AIRPLANES (PART 3, SPAIN AND YUBA CITY, CA)

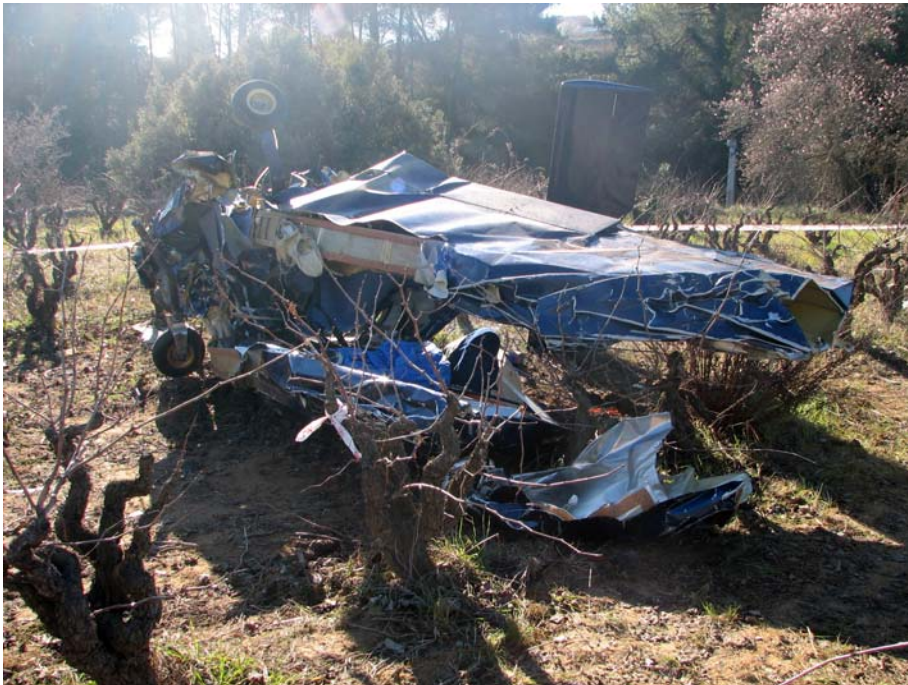
The Spain accident: the left wing wrapped around the fuselage, the right wing was relatively straight.

Left wing wrapped around fuselage

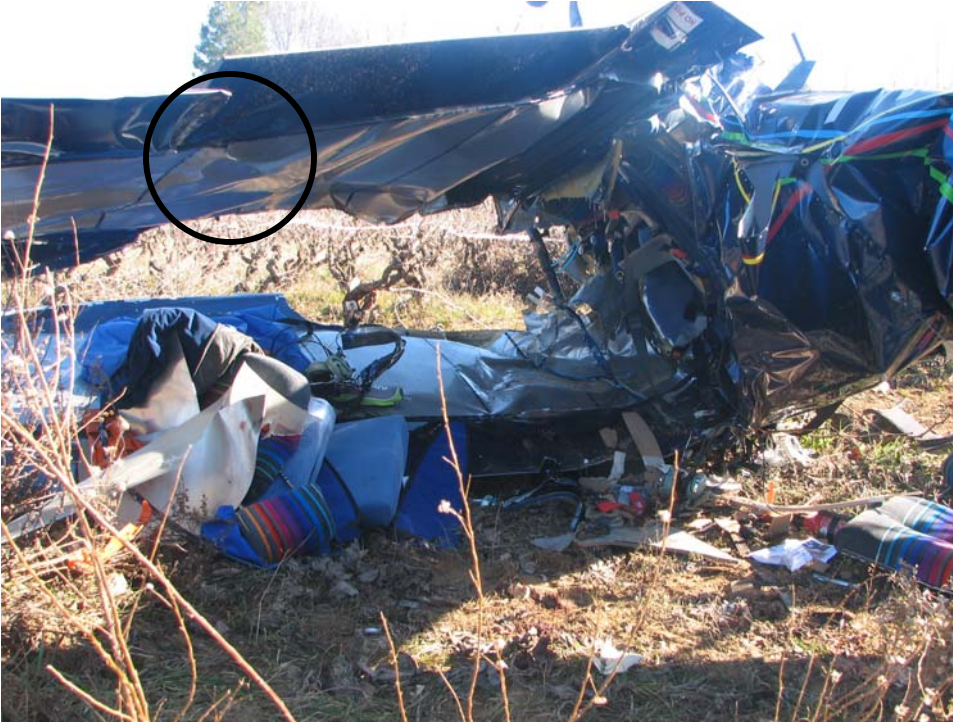
Typically, the compression buckling of the lower spar cap was at the lower edge of the hole that allowed the aileron push rod to pass through the rear spar web. The compression buckling of the upper spar cap was several inches inboard of the flap/aileron junction.

Right wing, upper buckle

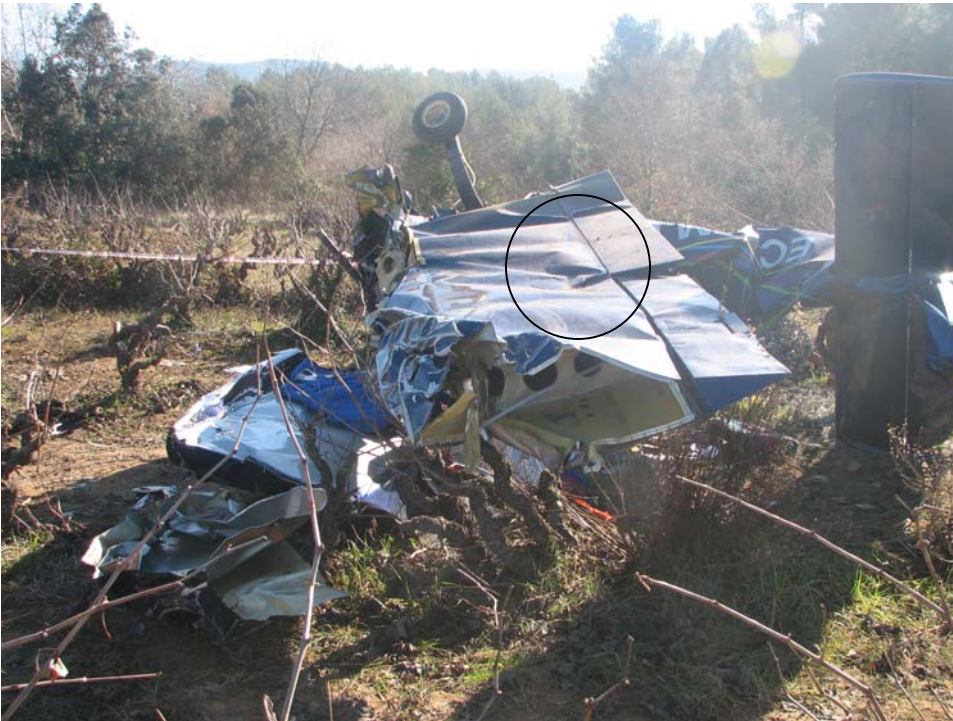
Right wing, lower buckle

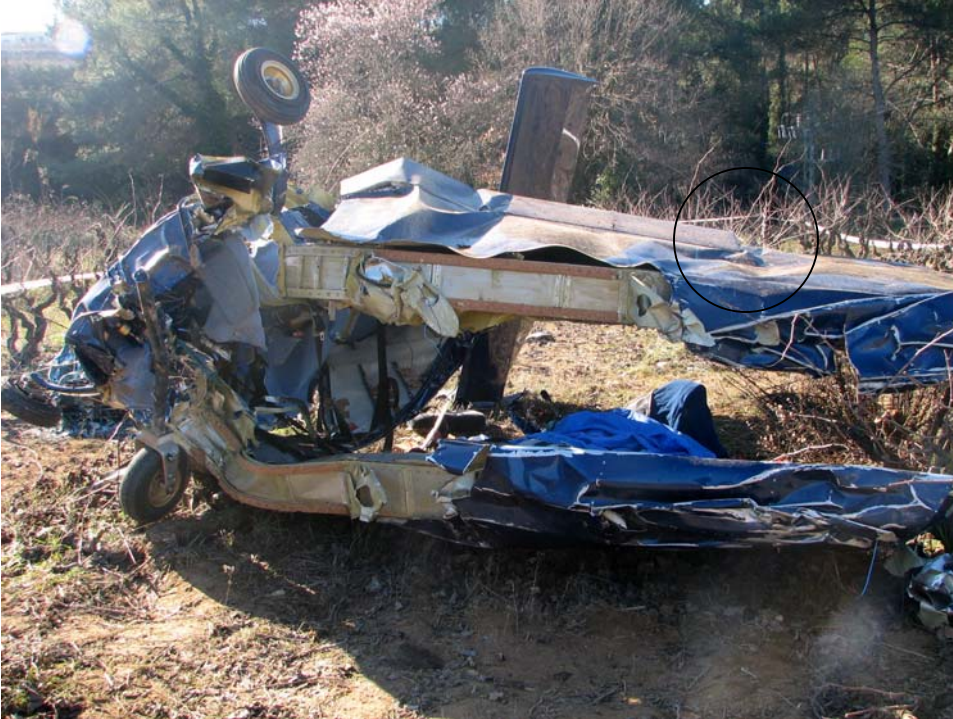
Right wing, lower buckle

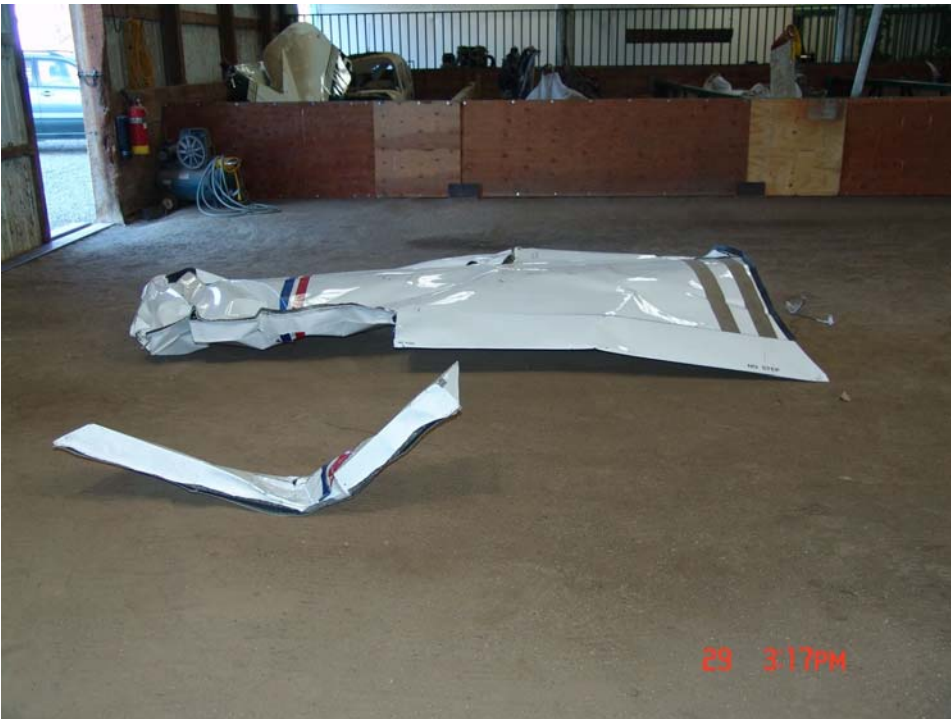
The Yuba City, CA accident: both wings broke in down bending.

Left wing, trailing edge

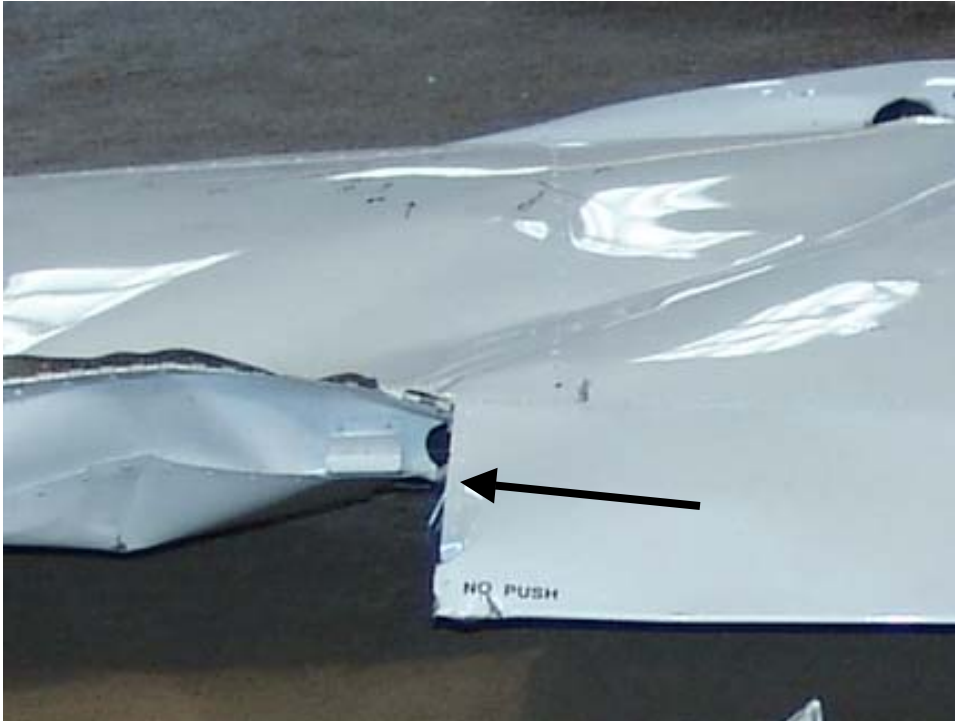
Left wing, trailing edge, close-up of buckle. Note buckle of top skin.

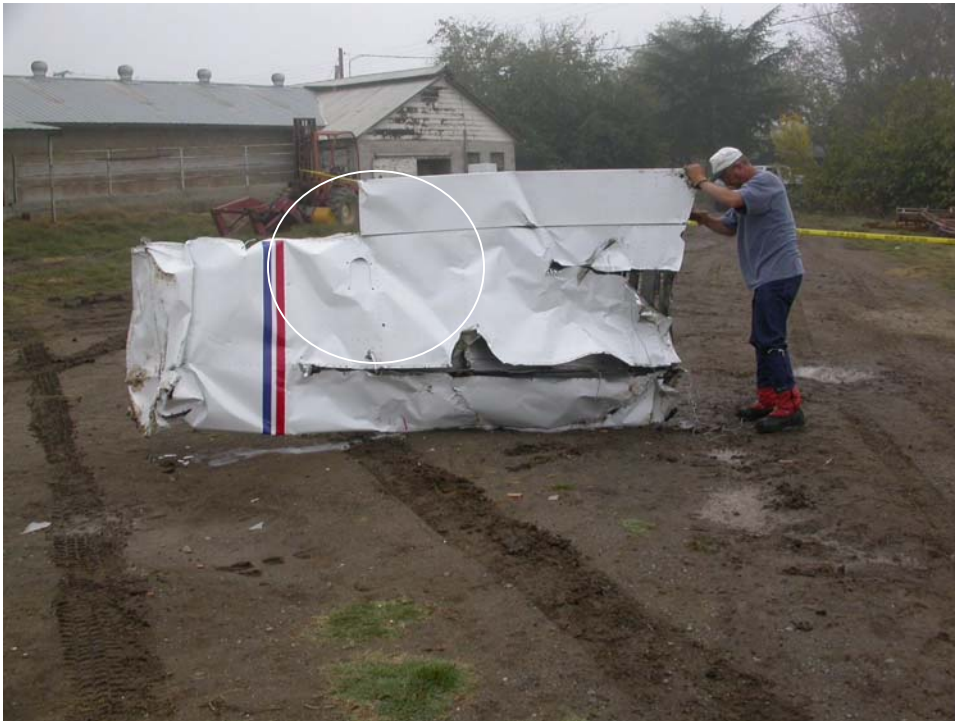
Left wing, bottom buckle

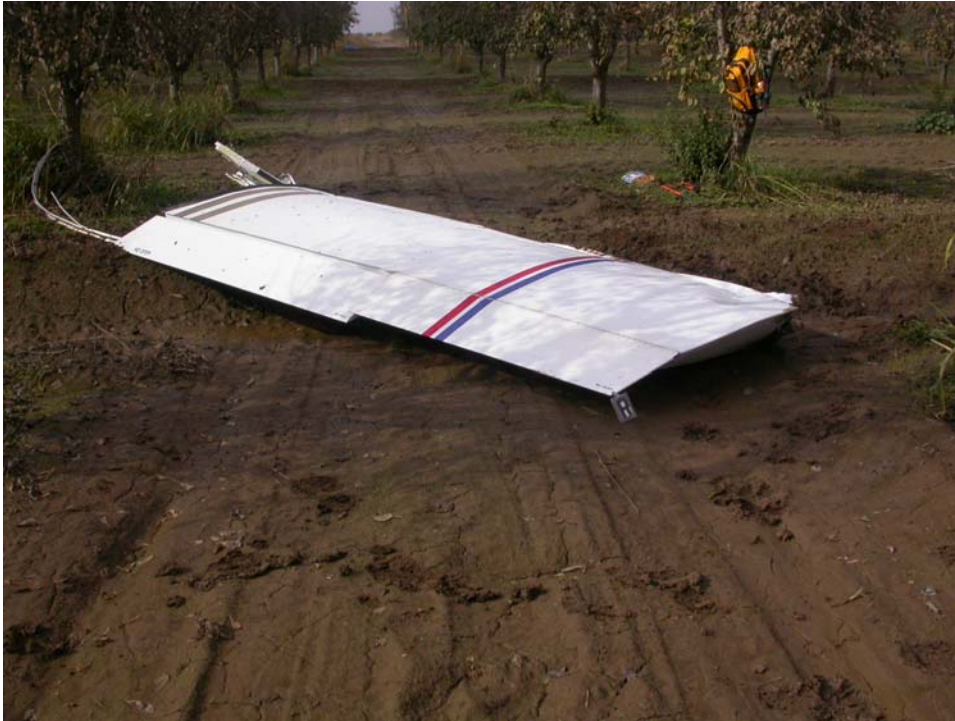
Right wing, top surface. No damage noted.
