# Nose gear bungee break on 601XL-B N554SG

- Bungee installed March, 2014.
- Bought new through Zenith, had recent manufacture date on part packaging.
- The break occurred either during a grass field landing or subsequent take-off. Due to grass conditions, it was not obvious if the bungee broke on landing other than I recall a slight nose down attitude during taxi-out for takeoff
- Bungee break became obvious when there was noticed a lack of rudder friction from the nose gear v-block after take-off
- Subsequent landing on hard surface was uneventful, but was accomplished power-off do minimize prop/engine damage had it been worse than just a broken bungee
- Welded ring on nose gear strut did it's job. Measured 7.5 inches of prop clearance with broken bungee compared to 11 inches with intact bungee.

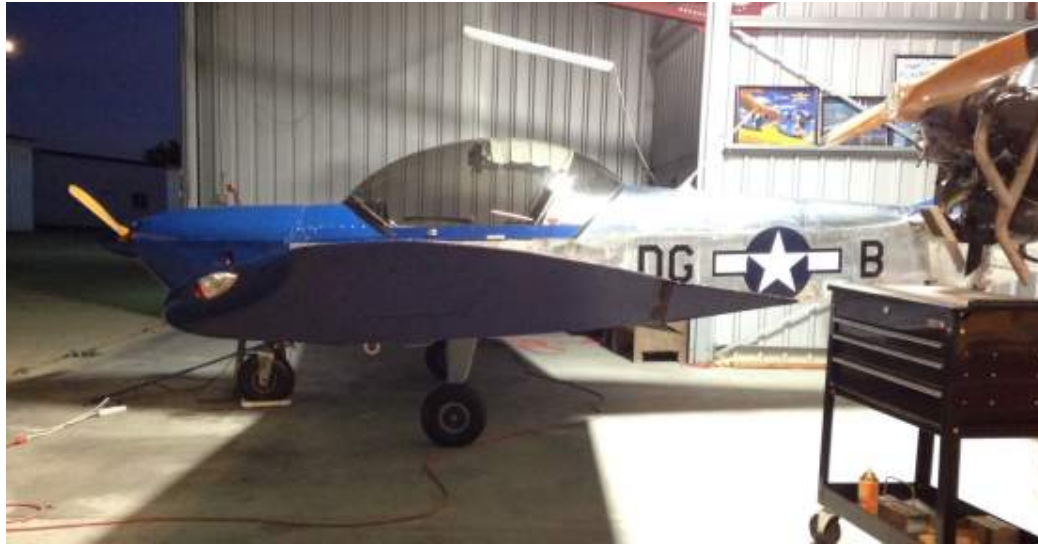
Slight nose down attitude noted, lose about 3.5" of strut length with broken bungee

This should be down here

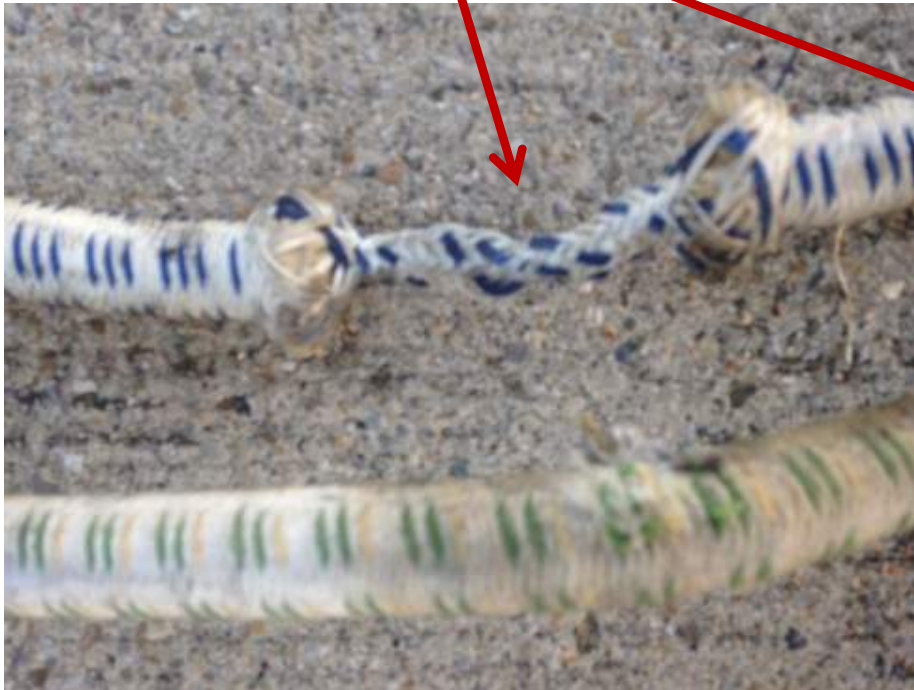
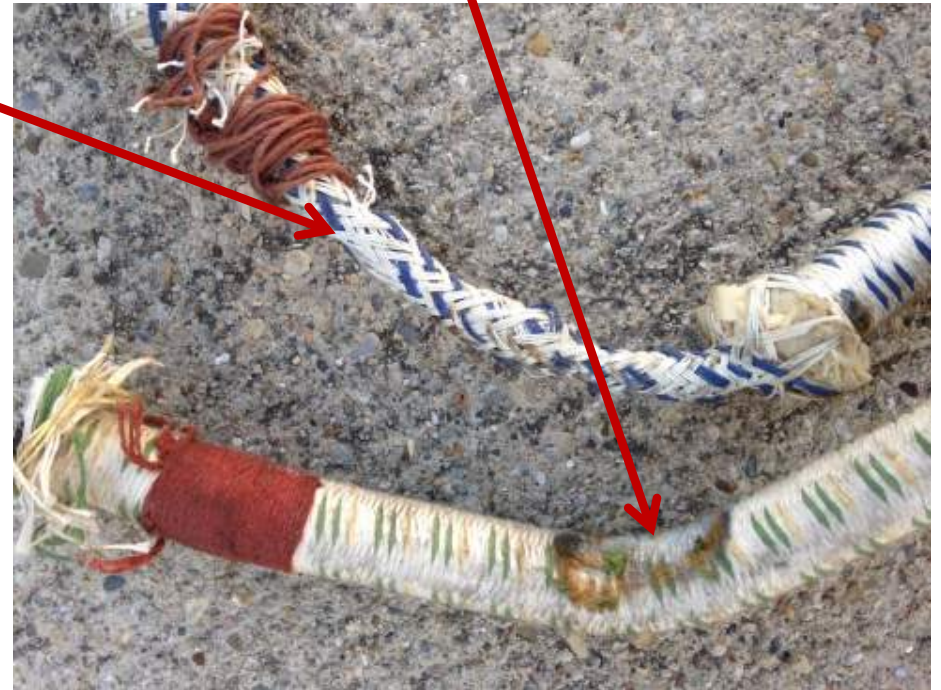
Cloth covering still intact with no signs of hard rubbing or chemical contamination

Superficial contact marks on old bungee where it wrapped around gear pins

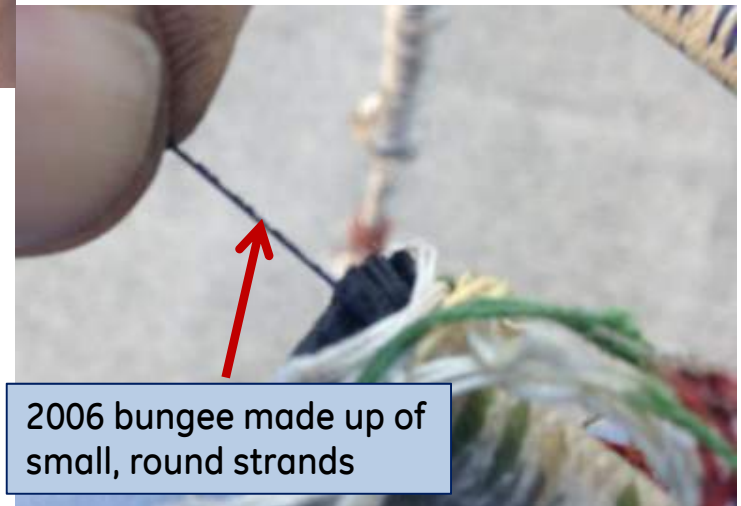
2014 bungee made up of wider, flat bands

2006 bungee made up of small, round strands

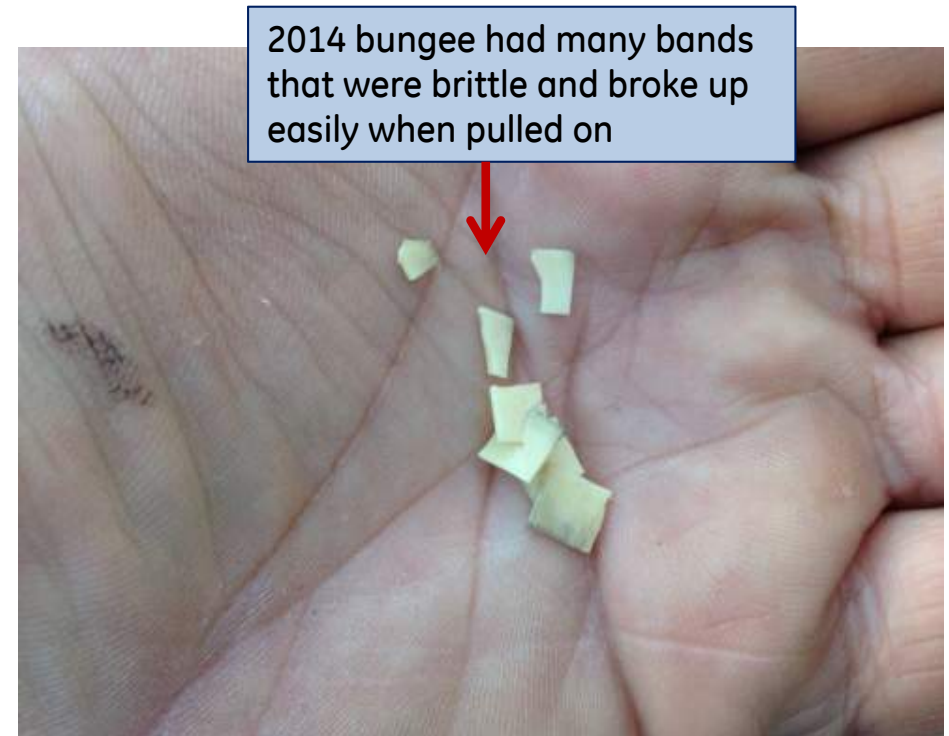
All 2006 bungee bands I could pull on were quite strong. Some 2014 bungee bands were also quite strong, while others were brittle and broke easily.
